# OH-13 and OH-23

## OH-13 AND OH-23 ACCIDENT SUMMARY

1 July 1966 through 30 June 1967

by  
P. R. Thompson

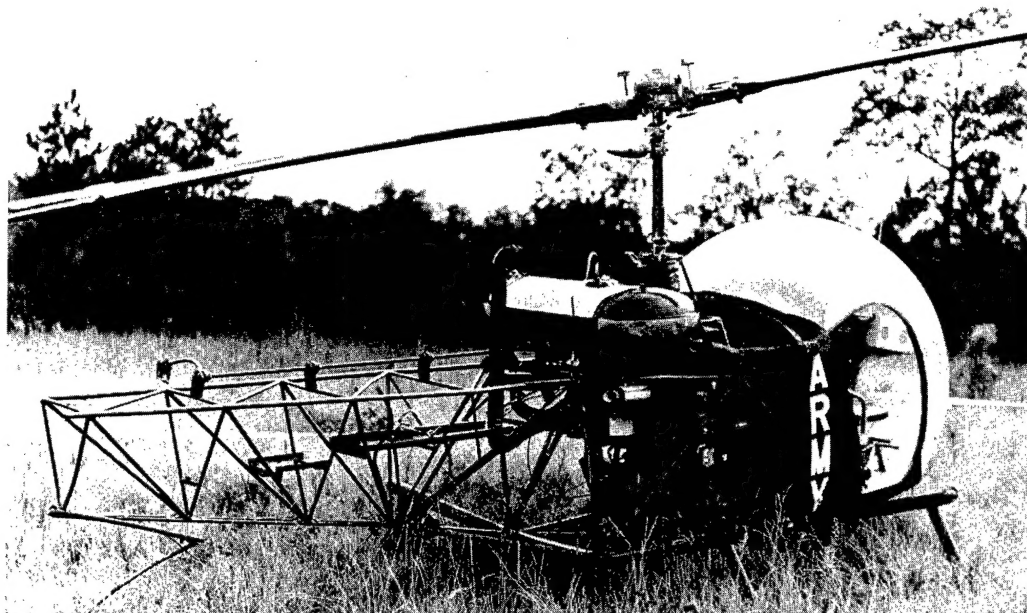
**F567**—RPM was lost during landing approach. Full throttle was added, collective pitch pulled, and aircraft flared, but rpm could not be regained. Aircraft entered high sink rate and full collective pitch was pulled at 10 feet to cushion landing. Aircraft hit on heels of skids, tail guard, and ventral fin, and bounced forward, with a main rotor blade flexing and severing tail boom. It then skidded left and settled to ground, damaging cross tubes, skid tubes, center frame, cabin, and tail rotor. Caused by allowing rpm to dissipate because of slow cross check, using improper technique for correcting low rotor rpm, and placing aircraft in high sink rate by flaring without completely lowering collective pitch.

**F567**  
RPM was lost and aircraft entered high sink rate. Improper technique was used for correcting low rotor rpm.

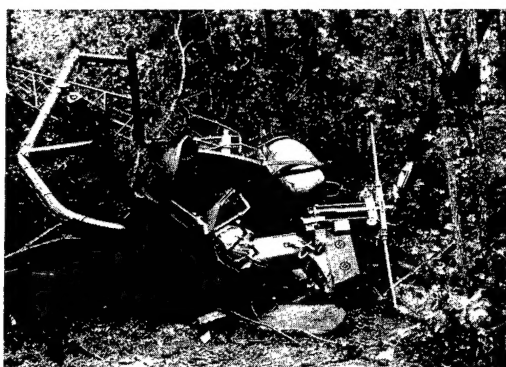
**G791**  
Aircraft settled and struck trees due to loss of translational lift. Poor quality control and inadequate maintenance supervision were factors.

**G791**—Downwind takeoff was made from confined area. Aircraft settled after clearing trees, struck trees, and crashed. Pilot was killed and aircraft destroyed. Caused by (1) loss of translational lift, (2) lack of quality control, and (3) inadequate maintenance supervision. Maintenance records for the 6-month period preceding the accident revealed that numerous partial and ineffective corrective maintenance actions had been taken without apparently correcting (1) continual magneto troubles due to improper timing, which caused a rough running engine, possible preignition and/or detonation; excessive cylinder head and oil temperatures; and lack of power; (2) continual trouble with No. 2 cylinder, ranging from bent push rods to "O" compression; (3) excessive oil consumption (No. 4 piston was changed because of engine throwing oil); (4) excessive smoke from right exhaust after starting; (5) fluctuating oil pressure; and (6) high cylinder head and oil temperatures. Engine teardown analysis revealed that engine was incapable of producing maximum power for high performance takeoff. Analysis also revealed loss of compression in three cylinders, magnetos out of time, loose spark plugs, and burnt piston rings. Iron content in engine oil had risen from 23 to 75 parts per million during 12-hour period before accident.

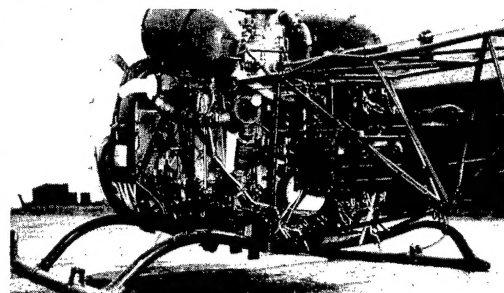
**G266** Improper removal and installation of tail rotor gearboxes due to poor supervision.

**G266**—Loud pop was heard during hover, left pedal hit stops, and aircraft turned right. Pitch was reduced to full "down" position and aircraft struck ground, damaging cross tubes. A whip action of the tail boom caused tail boom assembly to bend at upper left attaching point. Caused by improper removal and installation of tail rotor gearboxes.

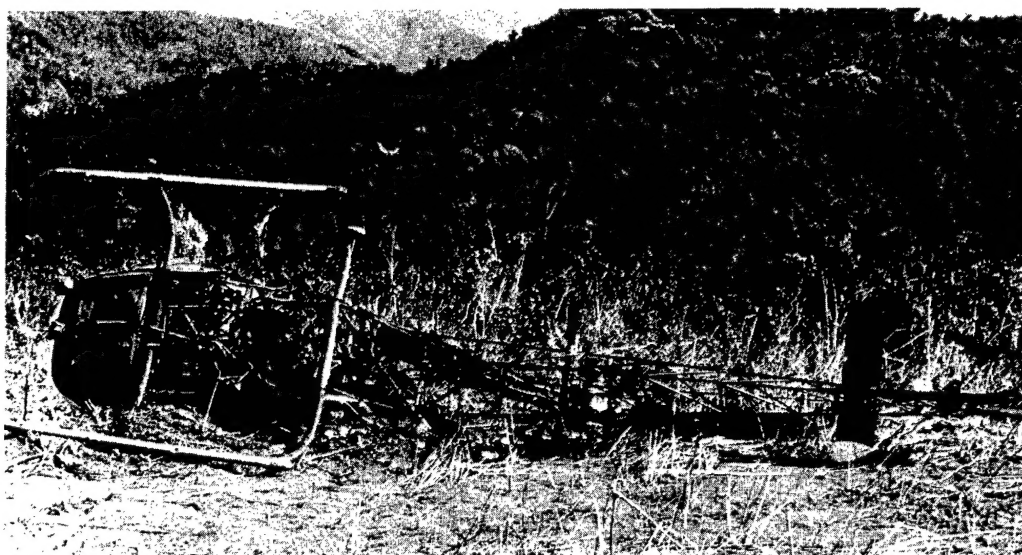
**020501**—Approach was made to hover and observer cleared tail rotor. Left skid was placed on ground and, as right skid was lowered, aircraft tipped right. Full left cyclic was applied, but aircraft continued to tip until main rotor struck ground. Pilot and observer escaped through broken bubble. Aircraft caught fire and burned. Caused by (1) allowing aircraft to tip too far for recovery, (2) landing on rough slope, (3) unimproved LZ, and (4) lack of provisions for ground guides.

**020501**  
Attitude got beyond recovery and aircraft was landed on rough slope. Pilot was relatively inexperienced and there was no improved LZ's or provisions for ground guides.

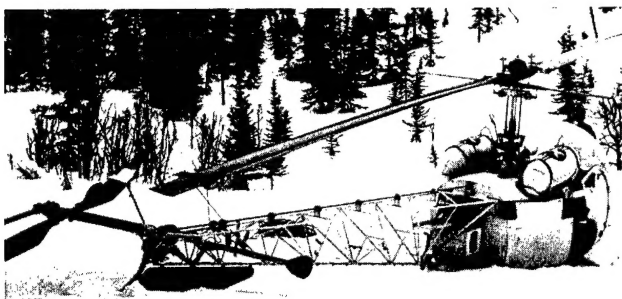
031709 Tail rotor struck tree. Suspect blowing snow prevented accurate judgment of hover height and hovering turn allowed tail rotor to swing upslope.

deep snow while passenger got out to remove flag-pole. Takeoff was made and area orbited until flag-pole was removed. Aircraft was then landed to pick up passenger. As aircraft was brought to hover during takeoff, left turn was made and tail swung into upslope, striking tree, damaging tail rotor blade, and severing tail rotor drive shaft. Aircraft began uncontrollable right turn, throttle was closed, and hovering autorotation was made. Caused by allowing tail rotor to strike tree. Suspect blowing snow prevented accurate judgment of hover height and turn allowed tail rotor to swing upslope.

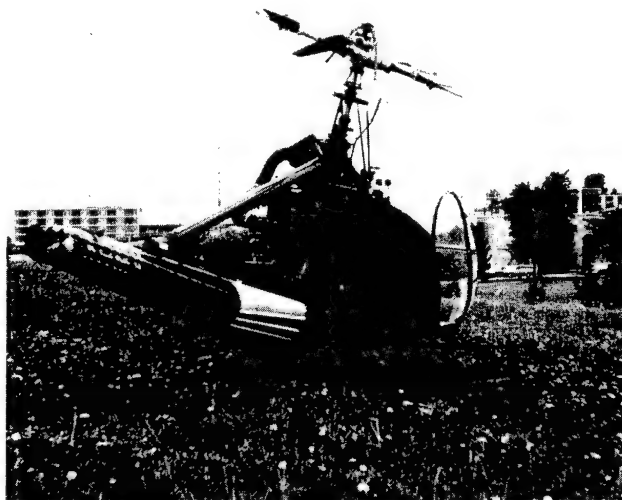
**F480** Application of excessive pitch during takeoff over low wires.

**F480**—RPM dropped rapidly during takeoff and aircraft settled, struck sloping area on right skid, and tilted left. Skids folded under and main rotor blade warped downward, cutting away 4 feet of tail boom. Pilot sustained minor injuries. Caused by application of excessive pitch.

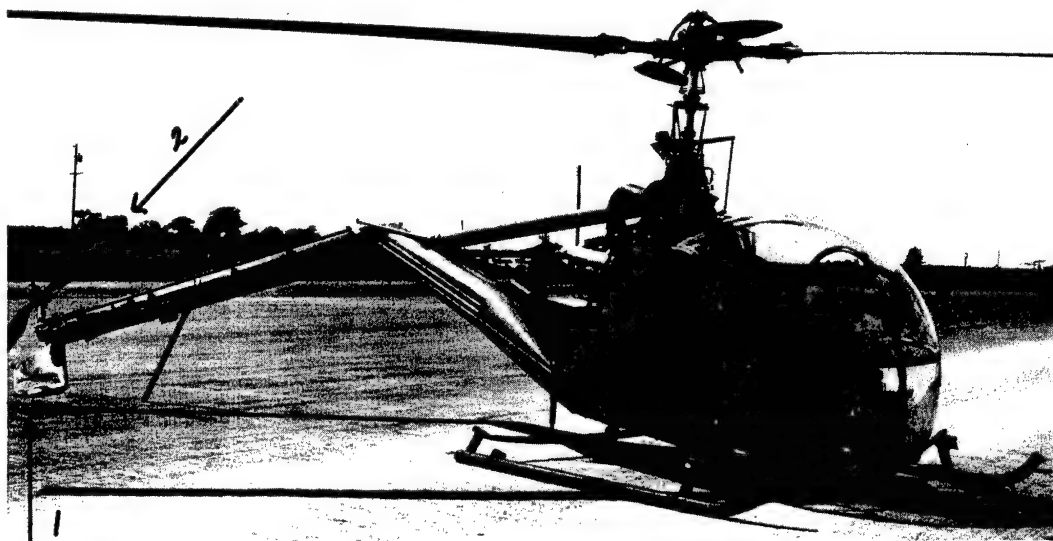
**G290**  
SP bottomed collective and IP failed to recover. IP was relatively inexperienced and violated training directive.

**G290**—SP was hovering through parking area to takeoff panel. IP cut throttle for simulated forced landing and SP bottomed collective. IP was unable to recover and aircraft landed hard, damaging tail boom, cross tubes, airframe, lower beacon, stabilizer, 1-inch drive shaft, and hanger bearing. Caused by (1) bottoming collective, (2) inability of IP to recover, and (3) violation of training directive.

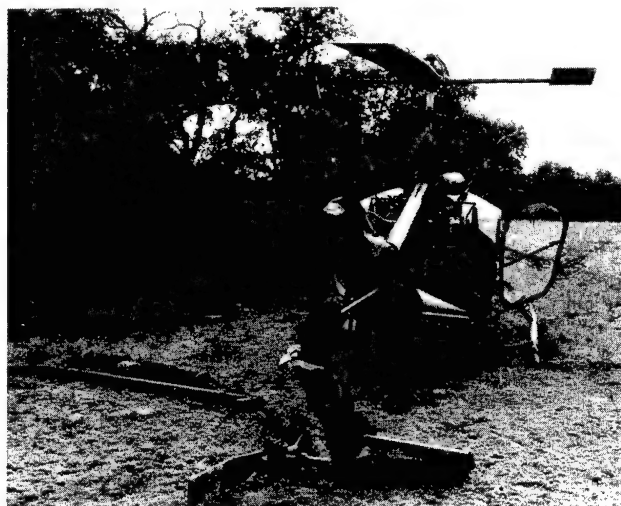
**H396**—Pilot heard thumping noise from engine and felt vibration in controls. Power approach was made and vibration continued. Engine ran rough and failed at 30-40 feet. Aircraft hit hard, damaging

**H396** Engine failed due to broken piston rings and damaged piston and a downwind landing was unsuccessful.

main rotor blades, 1-inch drive shaft, tail rotor blades, cross tubes, and tail boom. It came to rest upright. Engine failure caused by broken piston rings and damaged piston. Aircraft damage caused by downwind approach.

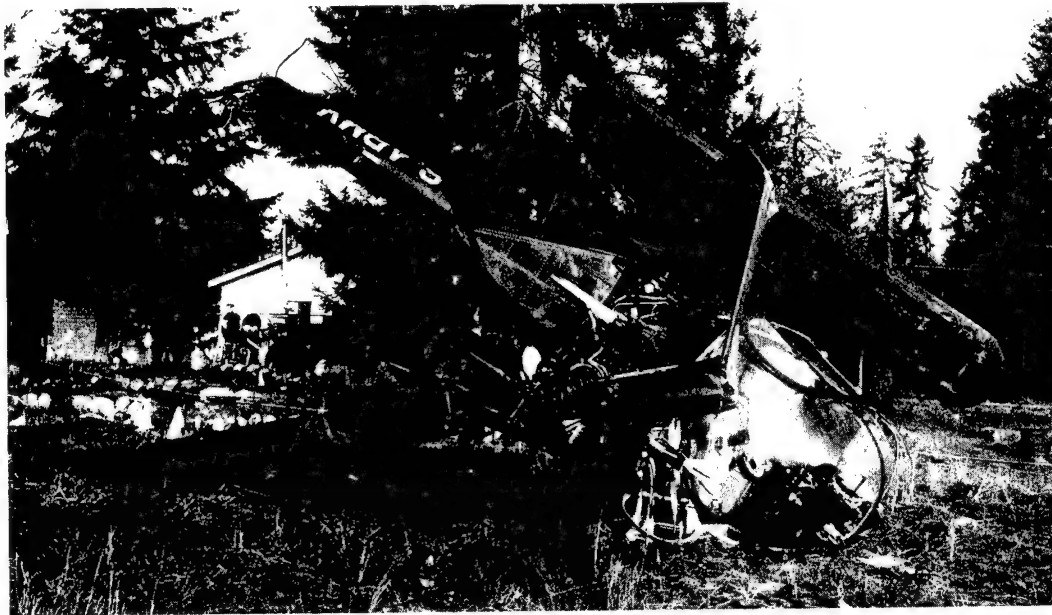
**013001**  
Engine failed due to failure of No. 6 connecting rod assembly. An extensive maneuver was performed during approach due to powerlines and touchdown groundspeed was excessive.
